Inspection Report Minerals Regulatory Program June 7, 2010

Mine Name: CMC ROCK Point South	Permit Number: S/035/0041
Operator Name: CMC ROCK LLC	Inspection Date: April 22, 2010
Inspector(s): L Heppler	Time: 7:30 am
Other Participants: none	Mine Status :Active

Purpose of Inspection: Routine annual Inspection. This site was inspected as a small mine site on 10/27/2009

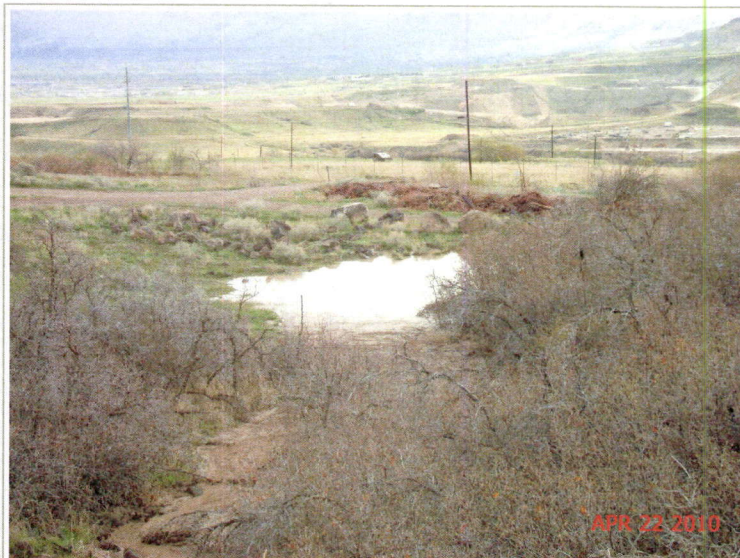
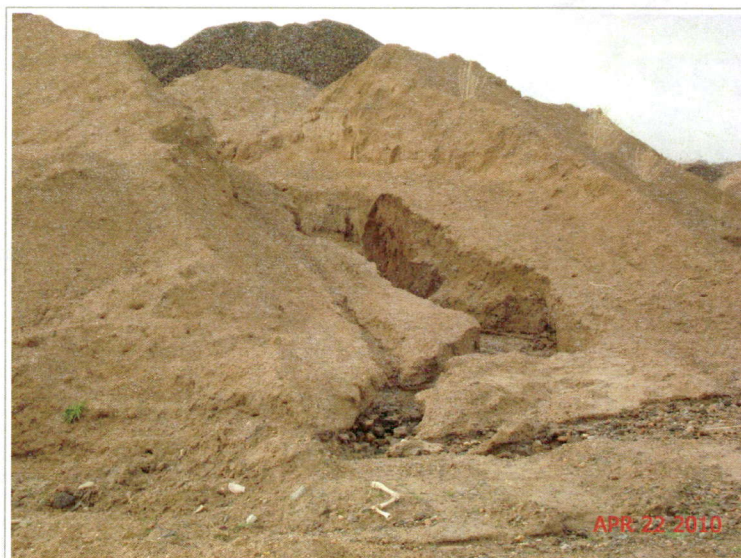
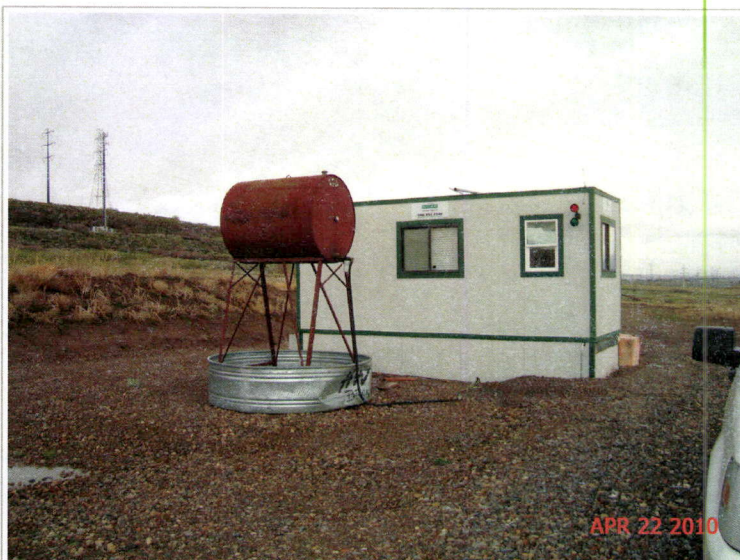
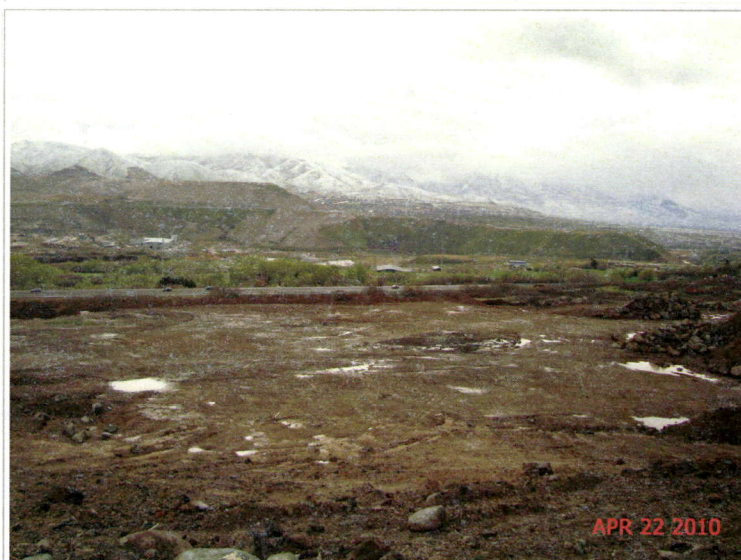
Inspection Summary: This site is accessed through a locked gate, but there is other entrances that can access the site. Erosion is evident at the site. All deleterious materials were properly stored. Topsoil was stockpiled at the upper edge of the excavation. No revegetation has been done. Photos were taken to document site conditions.

Conclusions and Recommendations: The Operator needs to put more effort into erosion control. This site appears to be operated by one Operator yet there is 2 permits for this site. The Operator either needs to do a large mine permit for 10 acres or Transfer the existing mine permit into the Operators name. Operator has 30 days to comply with all local, state and federal rules. OGM to continue annual inspections and monitor the site when in the area.
